A “Lengthy” Discussion of The Steel in the Debris of the WTC

Inspired by the Research of Dr Judy Wood

Andrew Johnson

November 2007

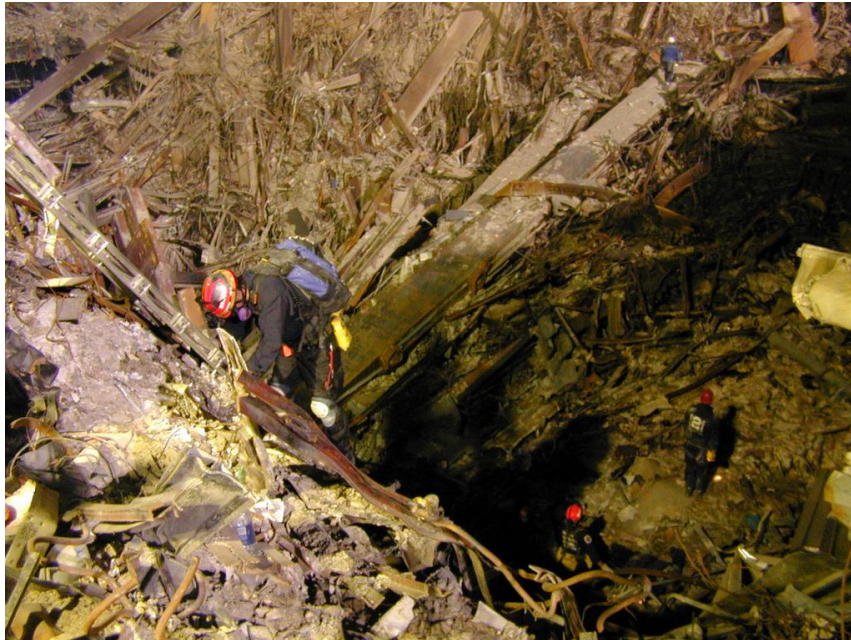
Figure 4-1 - GZ workers descend into the subbasements below WTC2. While there is extensive damage, there is little building debris at the bottom of the hole. There is no sign of molten metal. A worker in the distance walks along a massive core column. (photo filed 9/18/01) [Source](#)

Photographs (and other evidence) that Dr Wood has presented illustrate that only a small or even tiny proportion of the total debris was in the WTC Basement Levels.

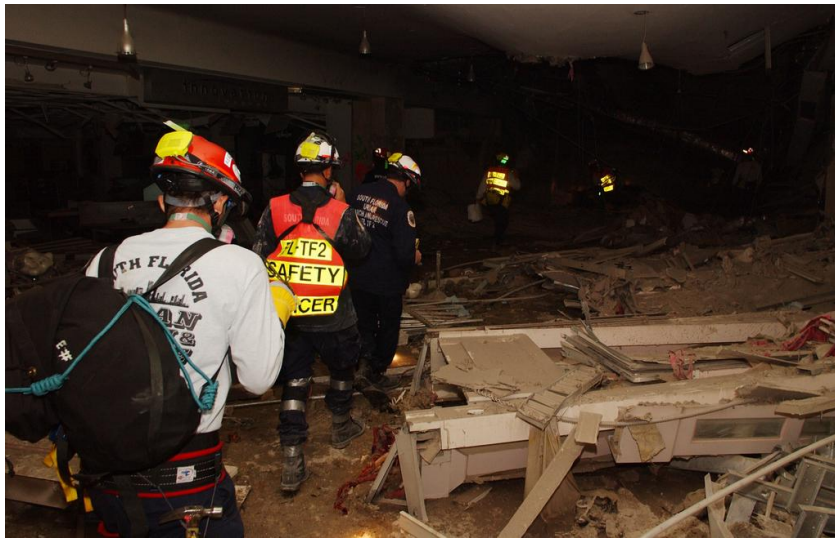
Figure 4-2 This photo was taken inside the mall. The store sign "innovation" is visible on the left.
(photo filed 9/19/01) [Source](#)

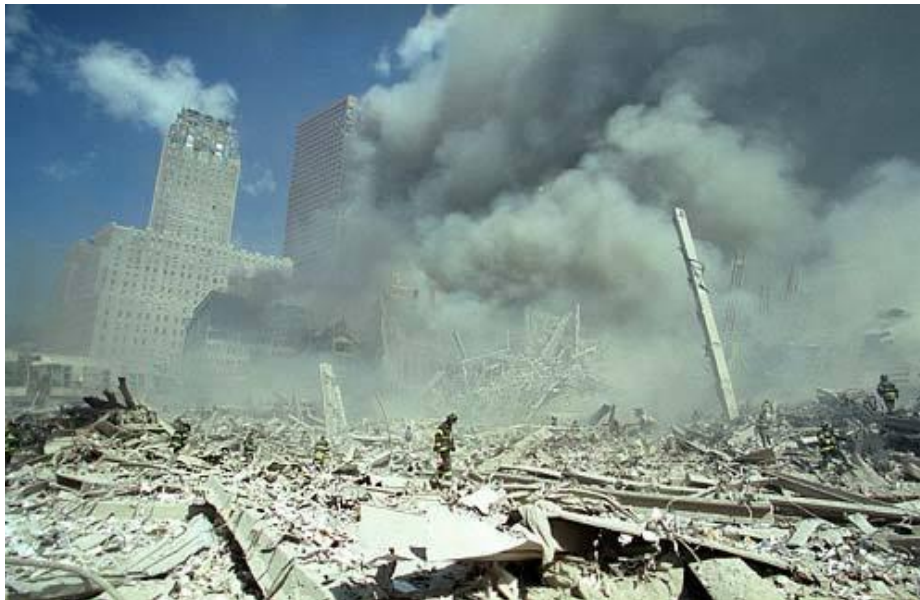
This picture would seem indicate there were very few long lengths of steel in the vicinity of WTC during the afternoon of 9/11.

Figure 4-3 - On the afternoon of 9/11/01 the "rubble pile" left from WTC1 is essentially non-existent. WTC7 can be seen in the distance, revealing the photo was taken before 5:20 PM that day.

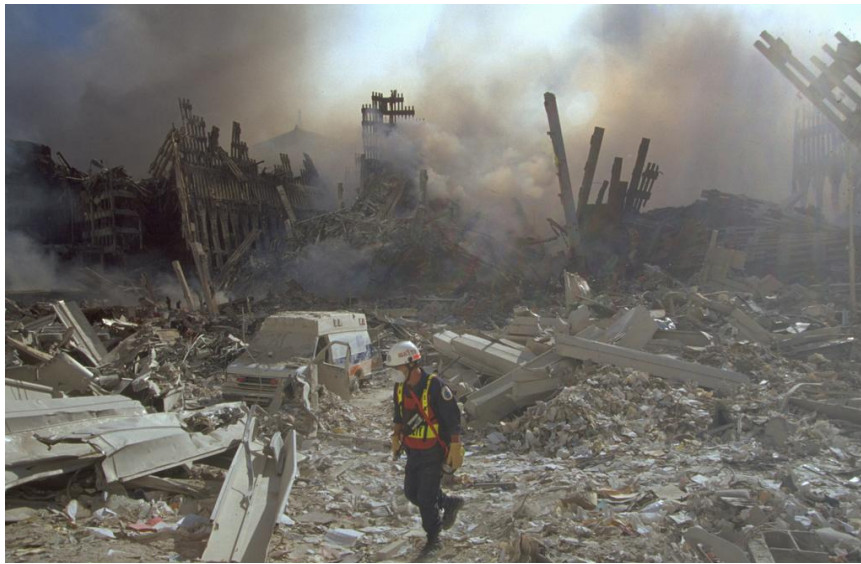
There only seem to be a few "Wheatchex" or long lengths of steel in all of the picture below. A conservative guess would perhaps be 100 "Wheatchex", in total, in all the pictures below:

Figure 4-4 here again we see the "rubble pile" from WTC1 is essentially non-existent. The ambulance is parked at ground level in front of WTC1. WTC6, which had been an eight-story building, towers over the remains of WTC1.

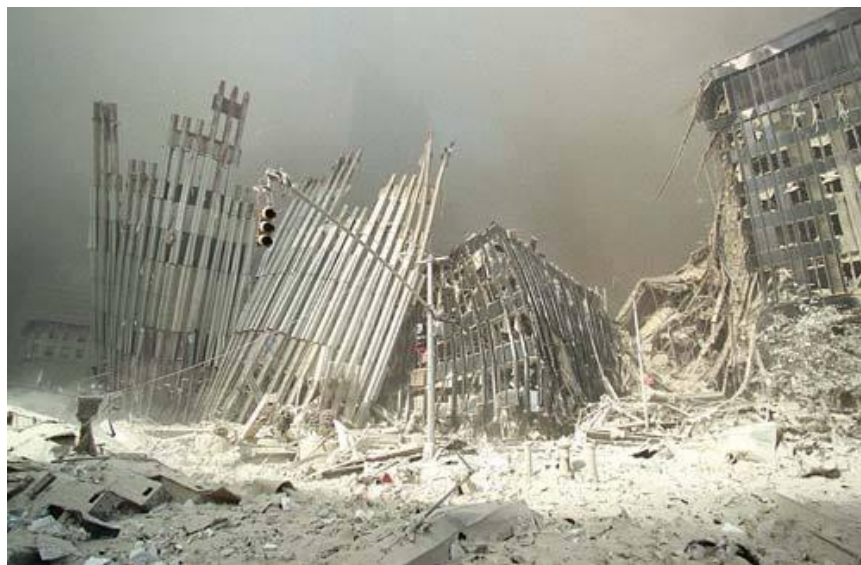
Figure 4-5 - The north wing of WTC4, as viewed from Church Street, looking west, appears surgically removed from the main body of WTC4, which has essentially disappeared. If WTC2 fell on it and squashed the main building, where is the part of WTC2 that did this?
